Re: GHR Foundry Site  
Dayton, Montgomery County, Ohio  
TDD: S05-9610-007  
PAN: 6C0701SIXX

The United States Environmental Protection Agency (U.S. EPA) tasked the Superfund Technical Assessment and Response Team (START) contractor, Ecology and Environment, Inc. (E & E), under Technical Direction Document (TDD) S05-9610-007, to assist the U.S. EPA On-Scene Coordinator (OSC), Paul R. Steadman, with drum sampling at the GHR Foundry (GHR) site, a former foundry located at 400 Detrick Street in Dayton, Montgomery County, Ohio (Attachment A, Figure 1). In response to a request from the Ohio Environmental Protection Agency (OEPA), U.S. EPA had conducted an initial site assessment of the GHR site on April 10, 1996. The site assessment report from the April 10th investigation contains available information on site history, a detailed site description, and analytical results from the April 10, 1996, sampling; this report was submitted to U.S. EPA on August 26, 1996. The drum sampling event was intended to provide additional information, specifically on-site hazards, to augment the August 26, 1996, report.

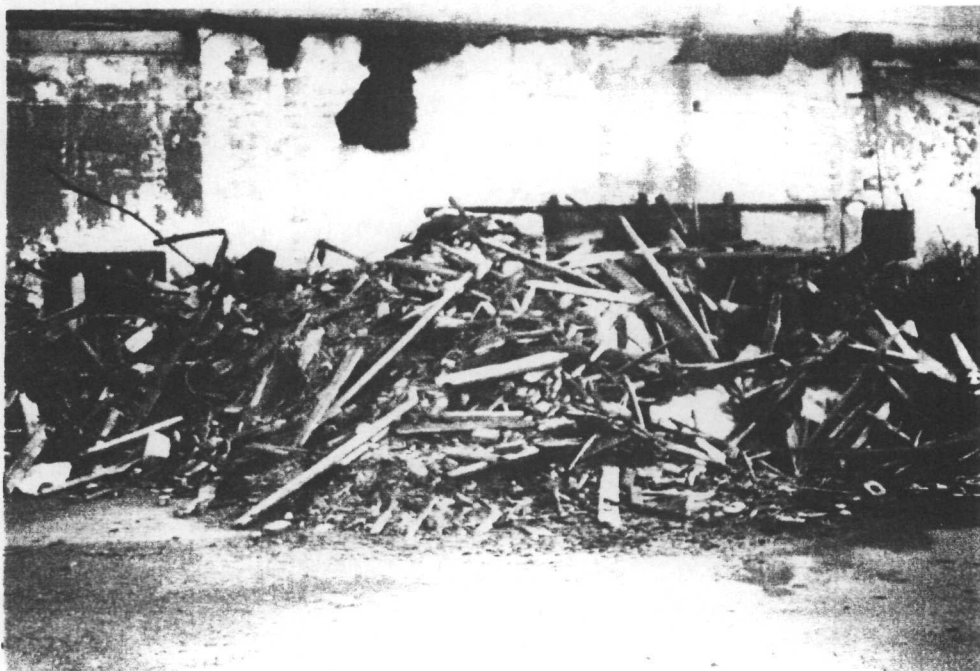
SITE NAME: GHR FOUNDRY  
 TDD #: S05-9610-007  
 DATE: OCTOBER 15, 1996  
 TIME: 1621  
 DIRECTION: S  
 PHOTOGRAPHER: LARRY LUECK

SUBJECT: Drum room blocked by debris piles.

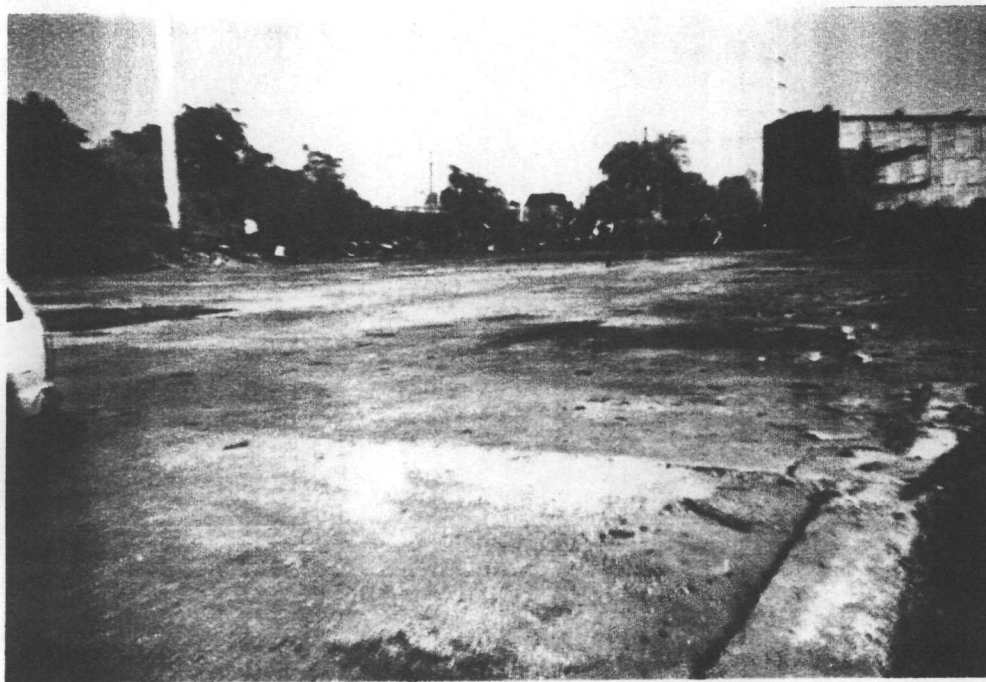
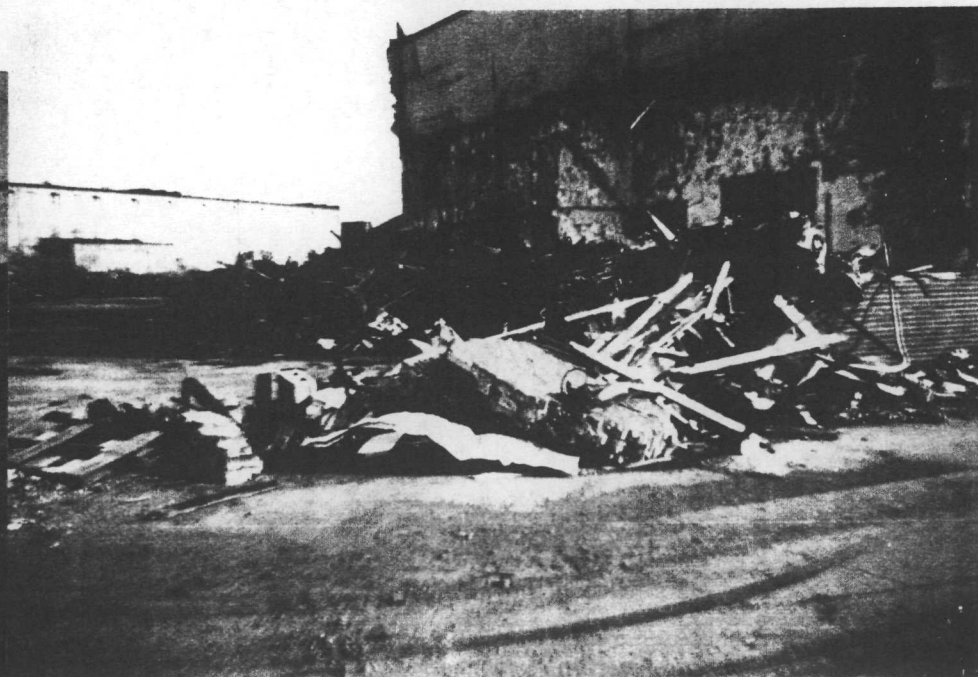
SITE NAME: GHR FOUNDRY  
TDD #: S05-9610-007  
DATE: OCTOBER 15, 1996  
TIME: 1628  
DIRECTION: NE to SE  
PHOTOGRAPHER: LARRY LUECK

SUBJECT: Panorama of NE corner of site,  
with blocked drum room, right.

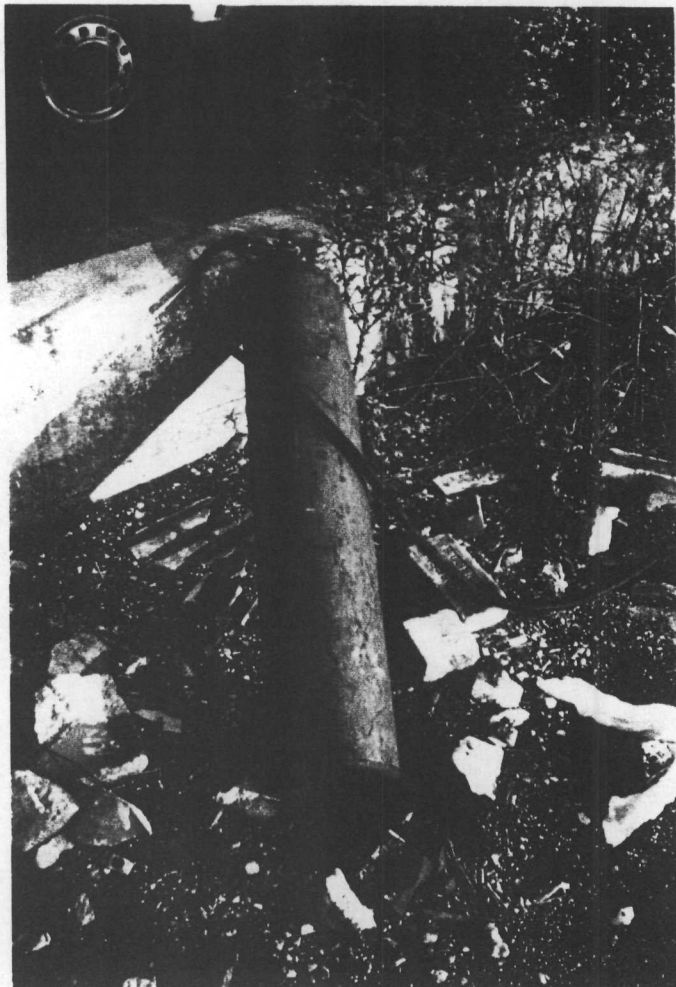
SITE NAME: GHR FOUNDRY  
 TDD #: S05-9610-007  
 DATE: OCTOBER 15, 1996  
 TIME: 1630  
 DIRECTION: SE  
 PHOTOGRAPHER: PAUL R. STEADMAN

SUBJECT: One of several  
 gas cylinders  
 found on site.

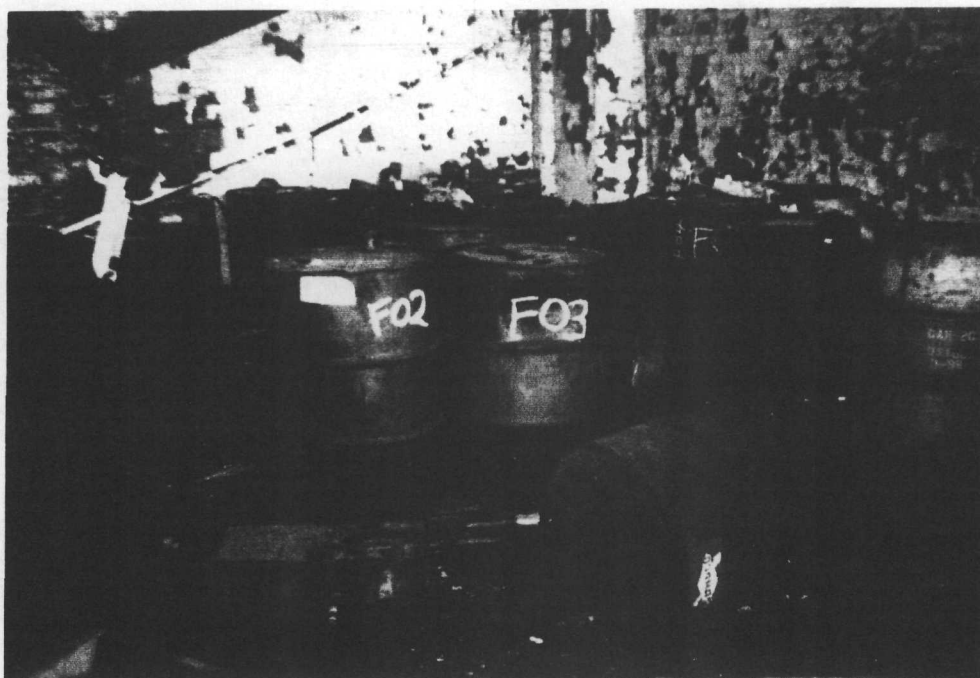
SITE NAME: GHR FOUNDRY  
 TDD #: S05-9610-007  
 DATE: OCTOBER 15, 1996  
 TIME: 1635  
 DIRECTION: SE  
 PHOTOGRAPHER: LARRY LUECK

The OSC requested that START sample three drums from another group of 23 drums standing in the southeast corner of the partially demolished building. Both START members donned level B protection, with the OSC providing backup. Three unlabeled drums with closed bungs were opened and sampled with drum thieves. Photoionization detector measurements collected at the bung immediately after each drum was opened are included in Attachment C, Table 1.

Drum sample GHR-F-2 consisted of a clear, honey-colored, somewhat viscous fluid. Drum sample GHR-F-3 consisted of a black fluid resembling used motor oil. Drum sample GHR-F-4 consisted of a clear, colorless fluid that seemed less viscous than the first two samples and was suspected of being a solvent. At the OSC's request, the three samples were analyzed for PCBs and volatile organic compounds (VOCs) by National Environmental Testing, Inc. (NET), in Bartlett, Illinois. On November 22, 1996, the OSC authorized START to additionally request that NET perform a flash point test on sample GHR-F-4, the most solvent-like of the three fluid samples. Results of analysis of the three drum samples are presented in Attachment C, Table 1. Sample GHR-F-4 is hazardous waste based on the ignitability characteristic (flash point < 140°F) (40 Code of Federal Regulations [CFR] 261.21).

SUBJECT: Sampled drums, displaying sample numbers.
